PASSAIC RIVER BASIN
MILL BROOK, MORRIS COUNTY
NEW JERSEY

DALRYMPLE POND DAM
NJ 00350

PHASE 1 INSPECTION REPORT
NATIONAL DAM SAFETY PROGRAM.

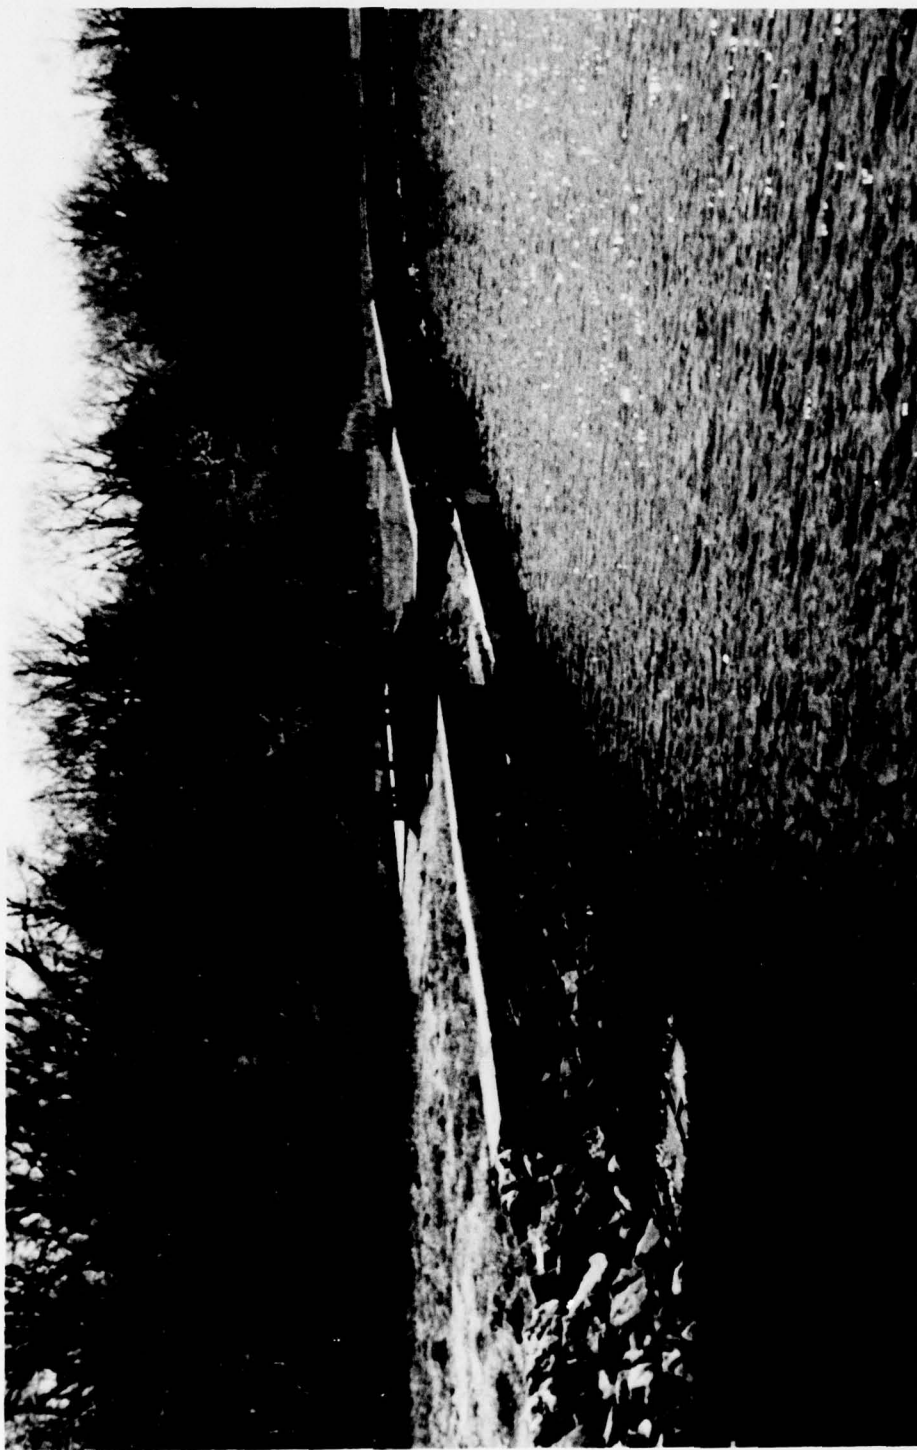
OVERVIEW - DALRYMPLE POND DAM

Based on visual inspection, past operational performance and Phase I engineering analyses, Dalrymple Pond Dam is assessed as being in fair overall condition.

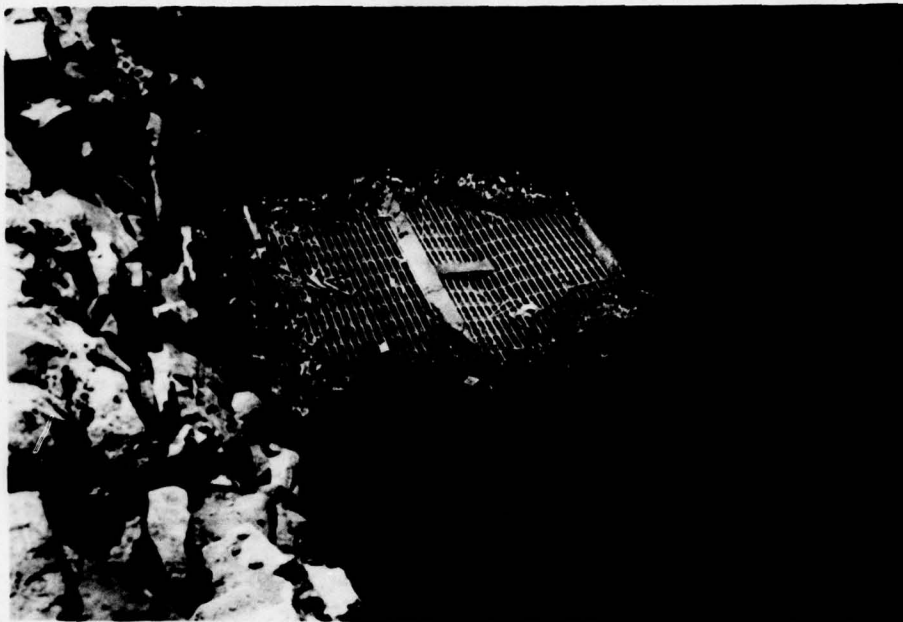
The drop inlet and its discharge pipe appeared to be in good condition. The steel grate spanning the drop inlet is dented but appeared to be structurally sound at the time of inspection. The timber stoplogs which are used as controlled crest and outlet works appeared to be in satisfactory condition.

PHOTO 1
SPILLWAY

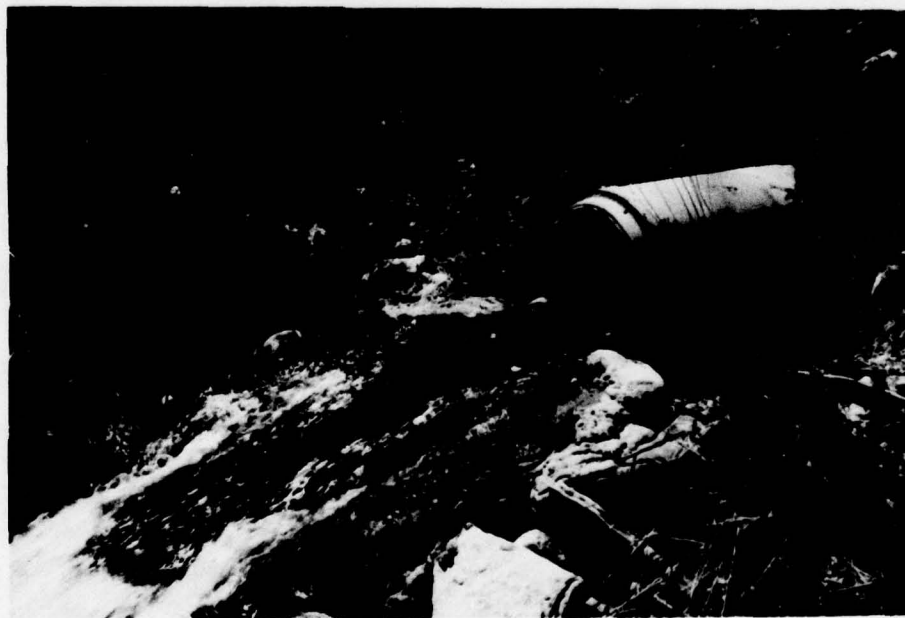
PHOTO 2
SPILLWAY DISCHARGE PIPE

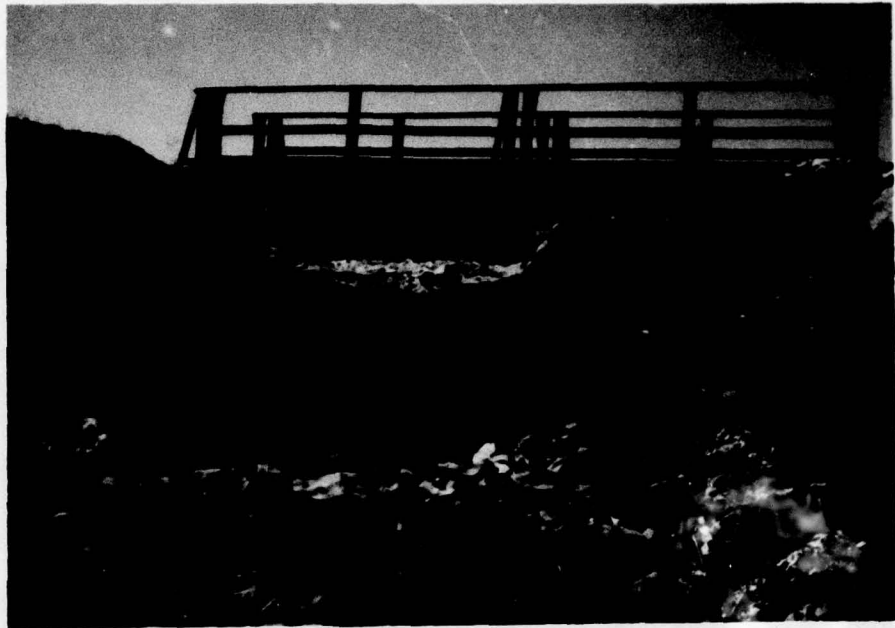
PHOTO 3

Auxiliary Spillway No. 1 is in a deteriorated condition. The concrete weir should be thoroughly renovated by patching, grouting and coating with an epoxy sealant. The junction between the dam and the discharge channel for Auxiliary Spillway No. 1 should be protected from erosion in the near future by the construction of training walls.

The walkway, composed of timber on steel beams, appeared to be in satisfactory condition. The concrete weir contains a rough, crudely cut notch that serves as primary crest. The concrete surface of the downstream face of the weir is deteriorated and soil has accumulated on the secondary crest.

AUXILIARY SPILLWAY - ORIGINALLY USED AS MAIN SPILLWAY

(1) Auxiliary Spillway No. 1 should be thoroughly renovated by patching, grouting and coating with an epoxy sealant.
